ULDB Flight 517NT
Anomaly Review Status Report
presented to
NASA Balloon Working Group

30 June 2003

Chairman, Flight 517 NT Independent Review Board

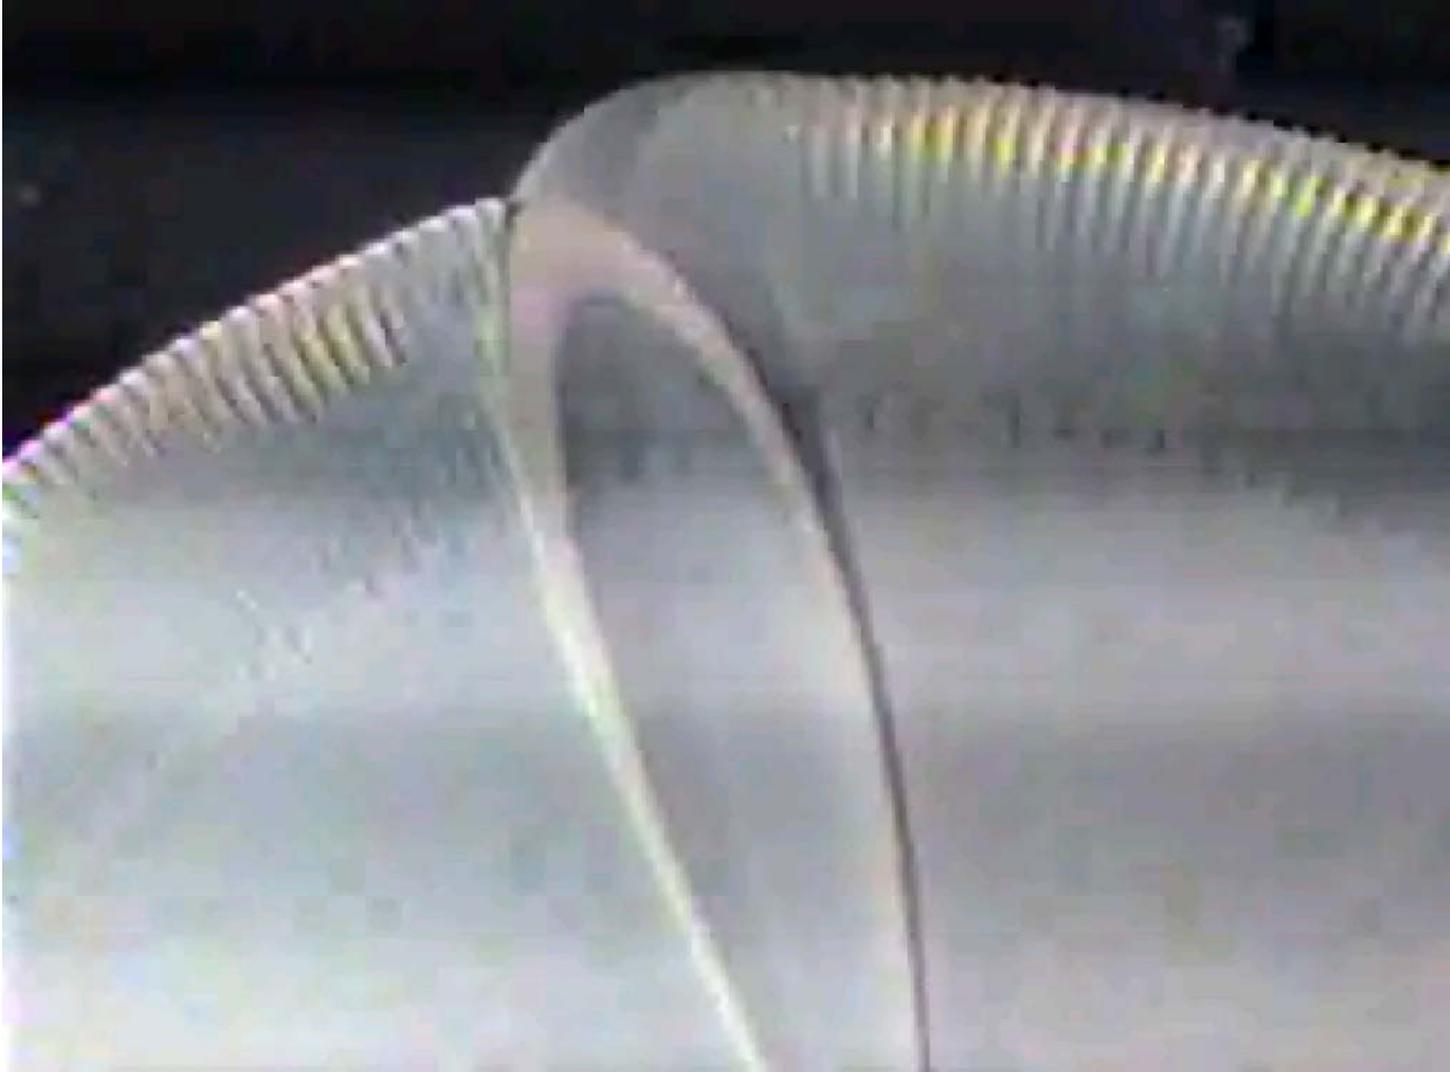
Cleft Observed During 517-NT

- At 2309Z on March 16, 2003, the ULDB/NIGHTGLOW mission was launched from Alice Springs Australia
- As the ULDB vehicle entered float altitude, a multiple gore "super-lobe" was observed (via up-looking video from the payload) in the balloon
- The balloon's differential pressure peaked at approximately 137 Pa before release of helium from the CAP and UTP helium valves at L+2.5 hours
- Differential pressure continued to decrease after valving ended
 - SINBAD simulations show that to match the rate of gas loss a hole 85% of the area of a helium valve is needed
- At L + 8.3 hours three ballast drops totaling approximately 500 pounds of ballast failed to arrest the pressure loss
- The flight was terminated at L + 11.5 hours

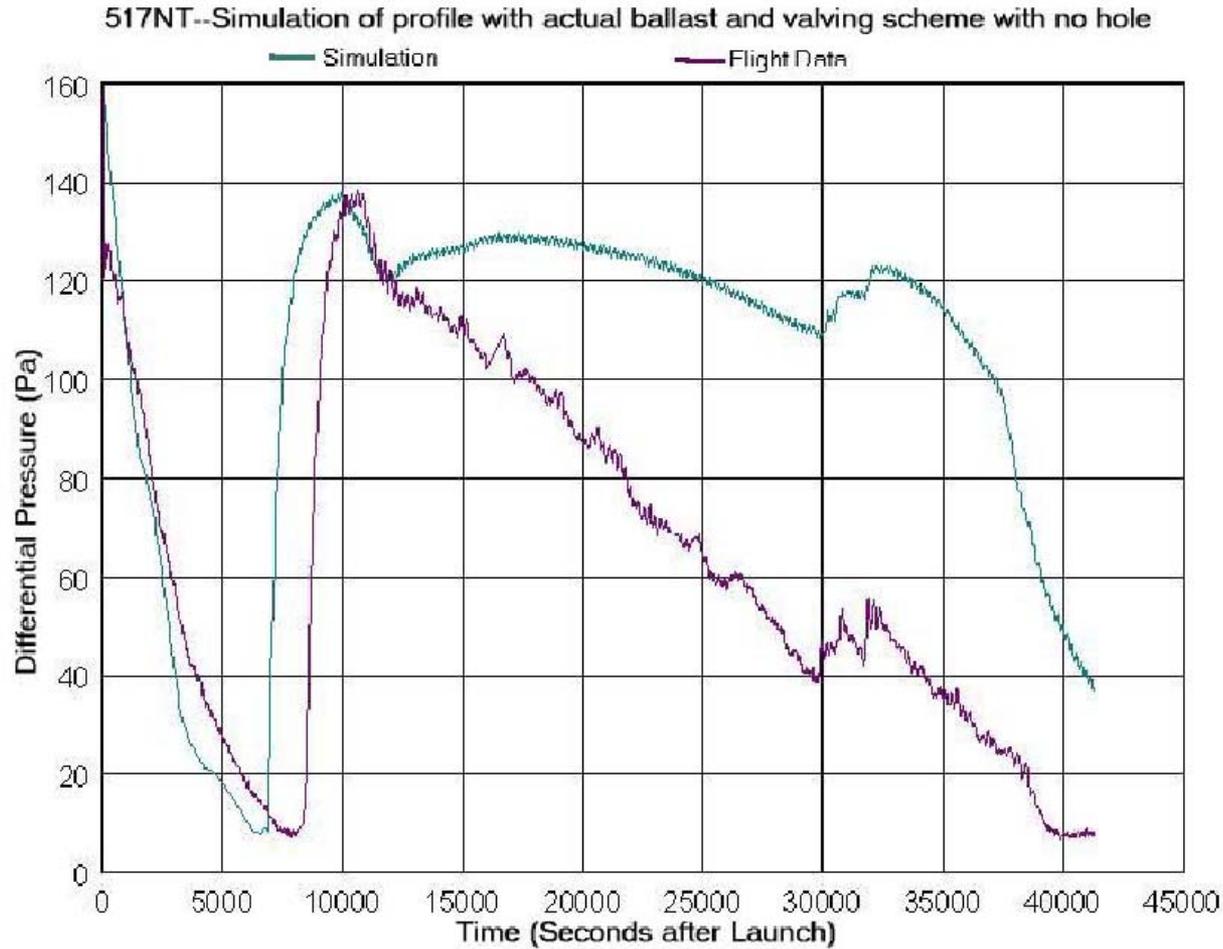
Flight 517NT Differential Pressure

- ◆ **The loss of pressure seems to start at nearly the same time as the completion of valving to reduce pressure from 137 Pa to 125 Pa**
 - **Extensive review and testing of the helium valve system (valve, electronics, telemetry/command interfaces) failed to show any anomaly or misoperation of either valve**

- **To duplicate the rate of gas loss experienced during 517 NT, it would be necessary for one of the valves to stick \approx 85% open**

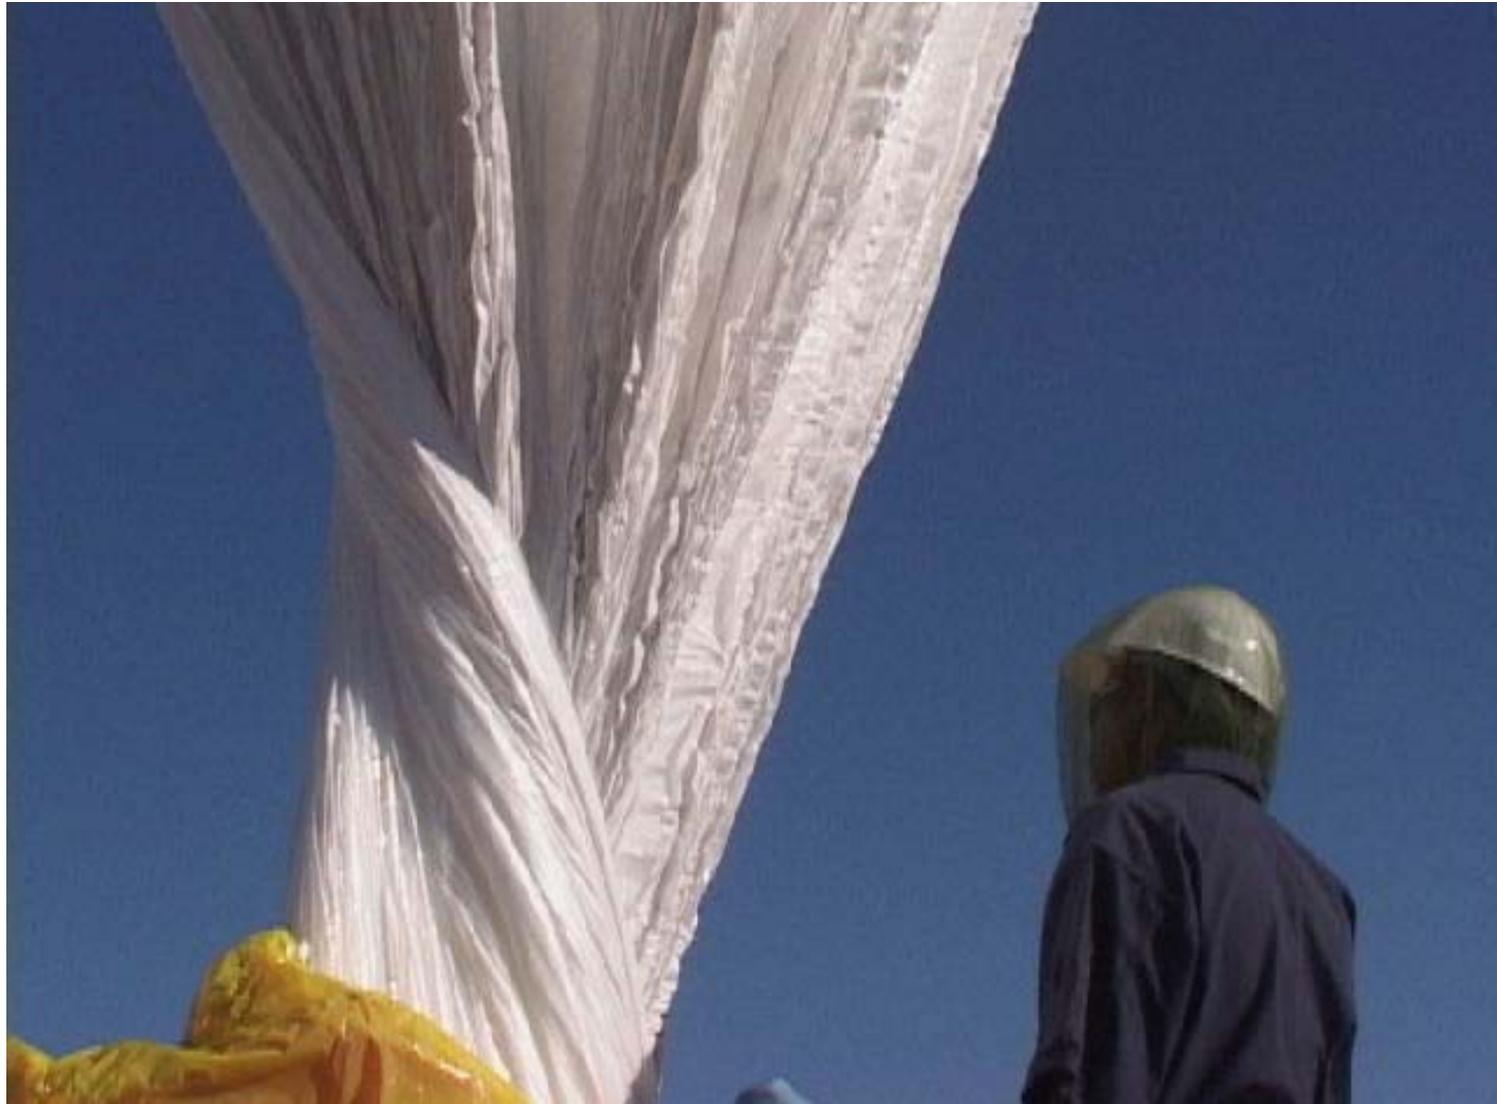
“Fold” Observed During Inflation

- ◆ **The flight line operations, inflation, launch and ascent of flight 517 NT appeared to be nominal**
 - **It was later discovered that a significant “rope” section had formed during inflation that could have stressed the balloon film**

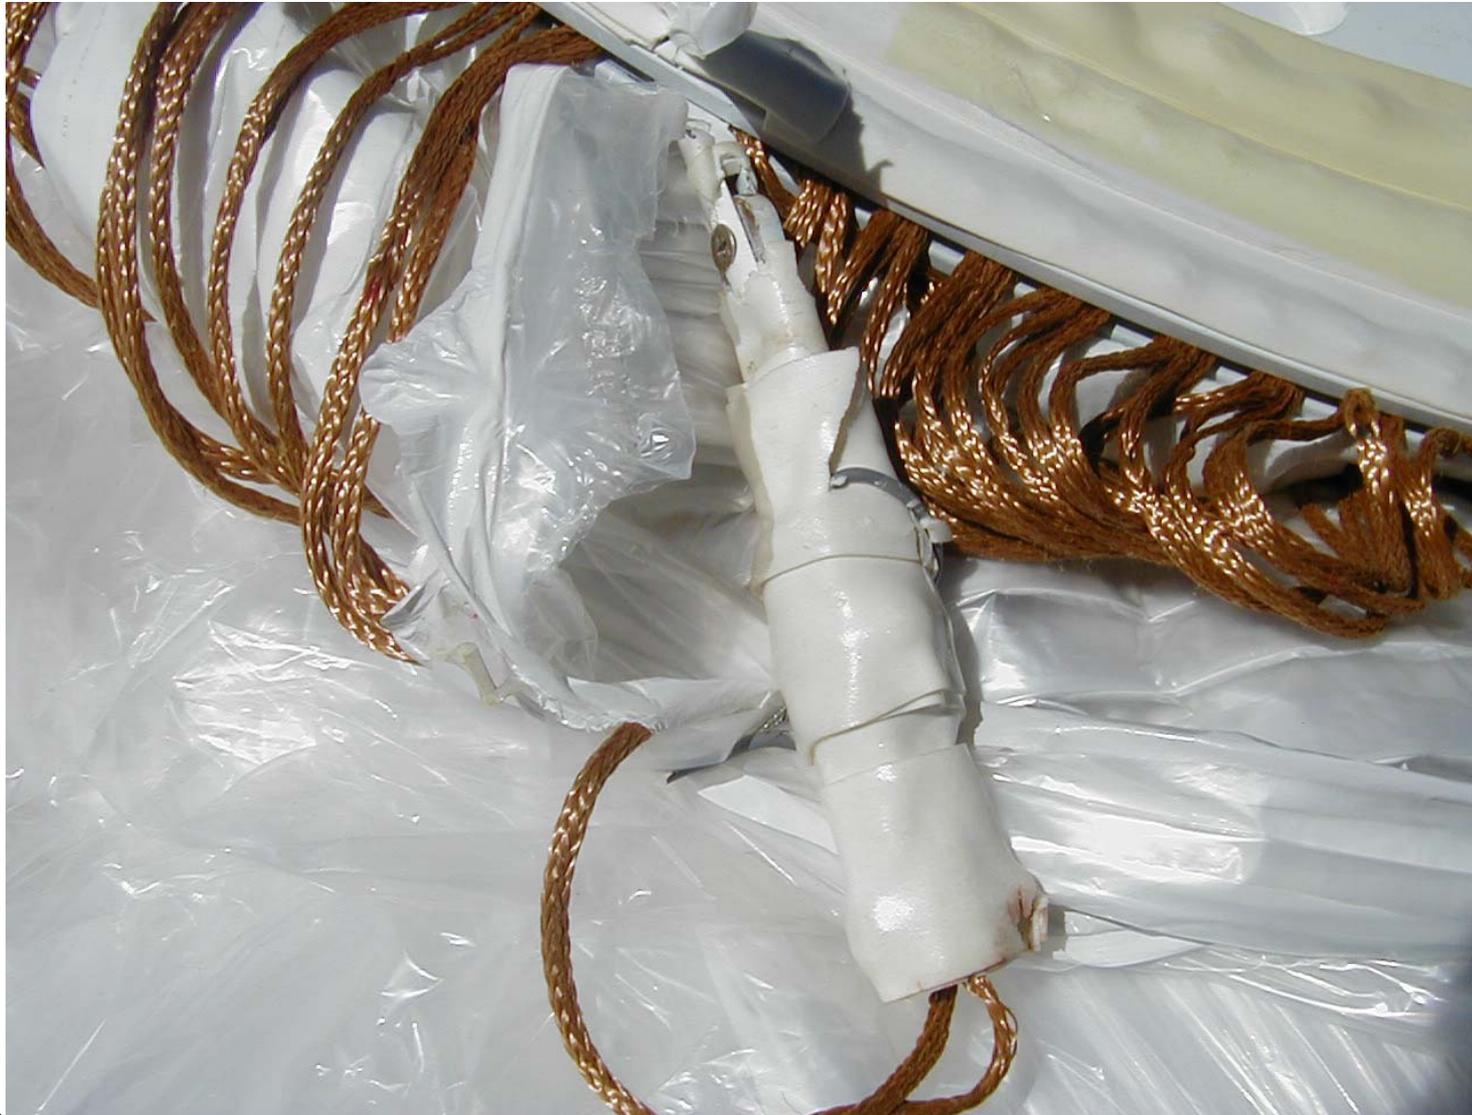
Load Cell Induced Damage

- **It was also observed that a load cell caused some damage to the film during launch and ascent**
 - **Load cell readings were zero before inflation, showed compression just as inflation started and changed to tension as the balloon began to pressurize**

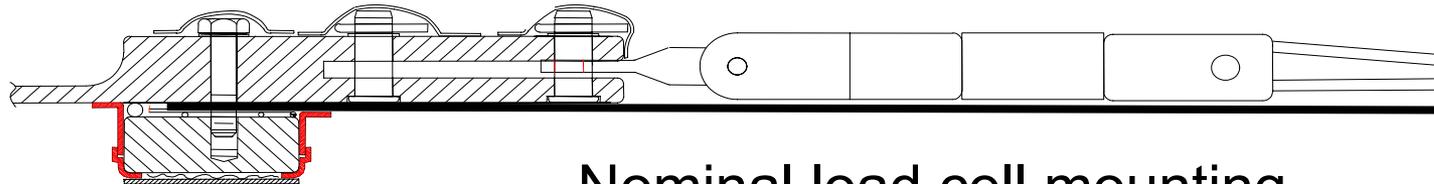
Nominal load cell mounting

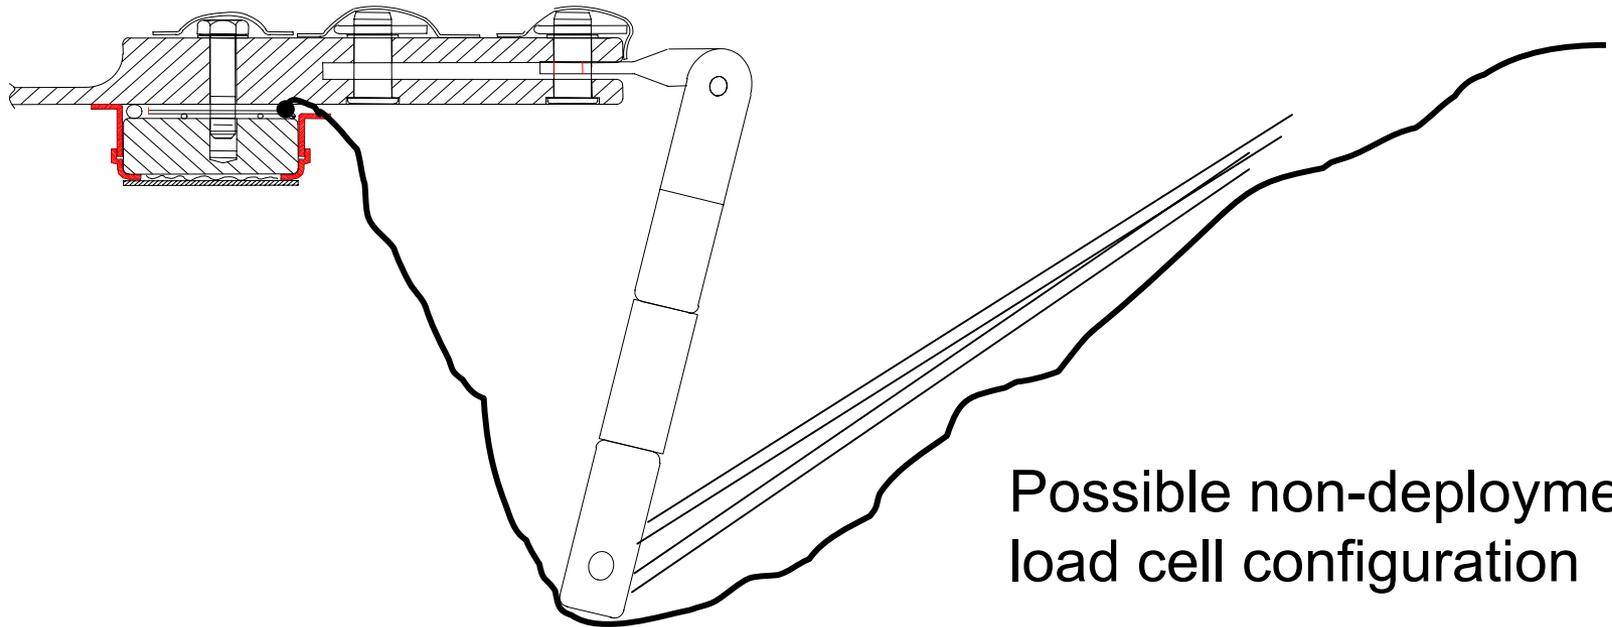
Possible non-deployment load cell configuration
